Deficiency Report

Subject Property

12345 Report St.

Observation Report

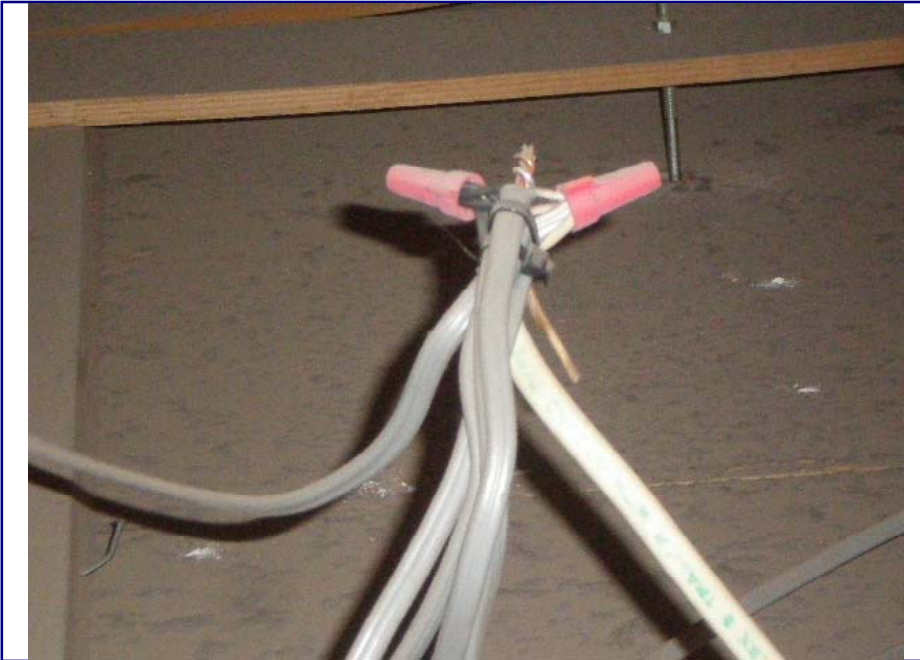
Picture 1

Exposed splices/ unprofessional wiring noted in the attic area, recommend electrician evaluate/ repair all wiring in attic area to help ensure proper, safe operation.(2)(4)

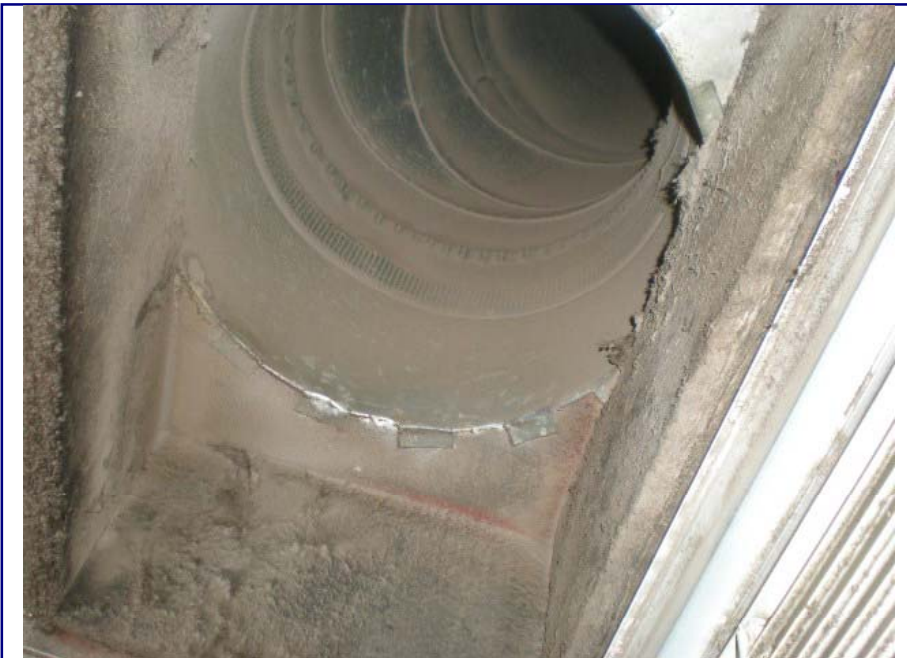
Picture 2

HVAC filter was missing at the time of inspection, recommend cleaning/ servicing system to help ensure proper, efficient operation.(2)

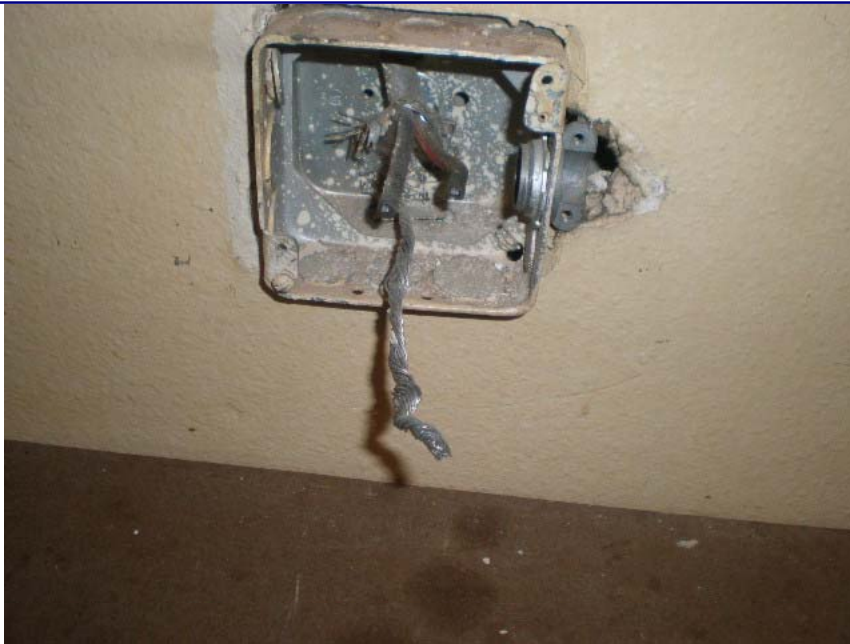
Picture 3

Exposed wiring at junction boxes at kitchen area.(2)(4)

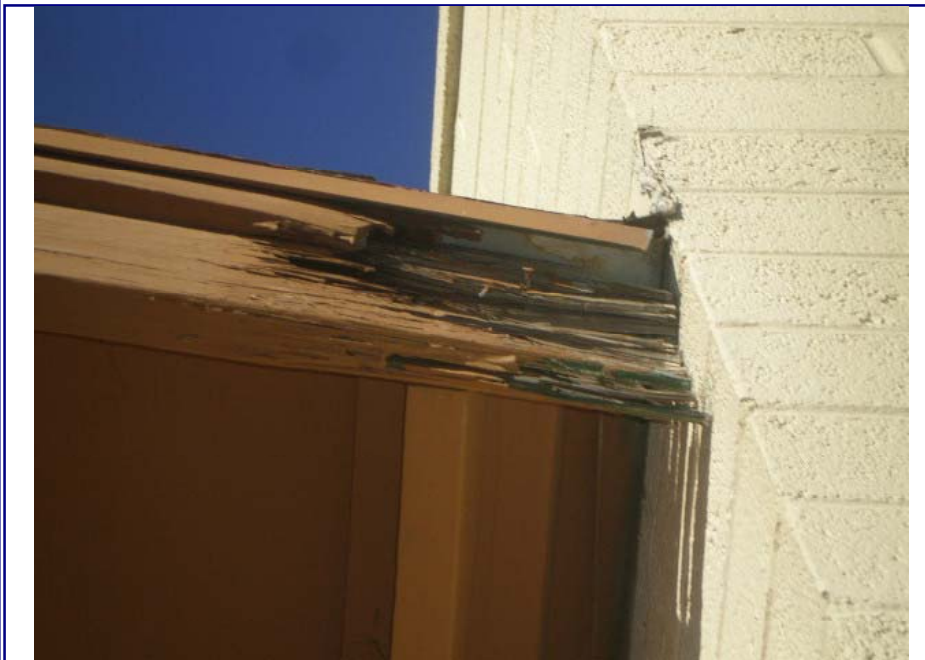
Picture 6

Damage/ deterioration noted at the fascia at the time of inspection.(2)
