## COMPREHENSIVE PROPERTY INSPECTIONS

Deficiency Report

12345 Report St.

# Observation Report

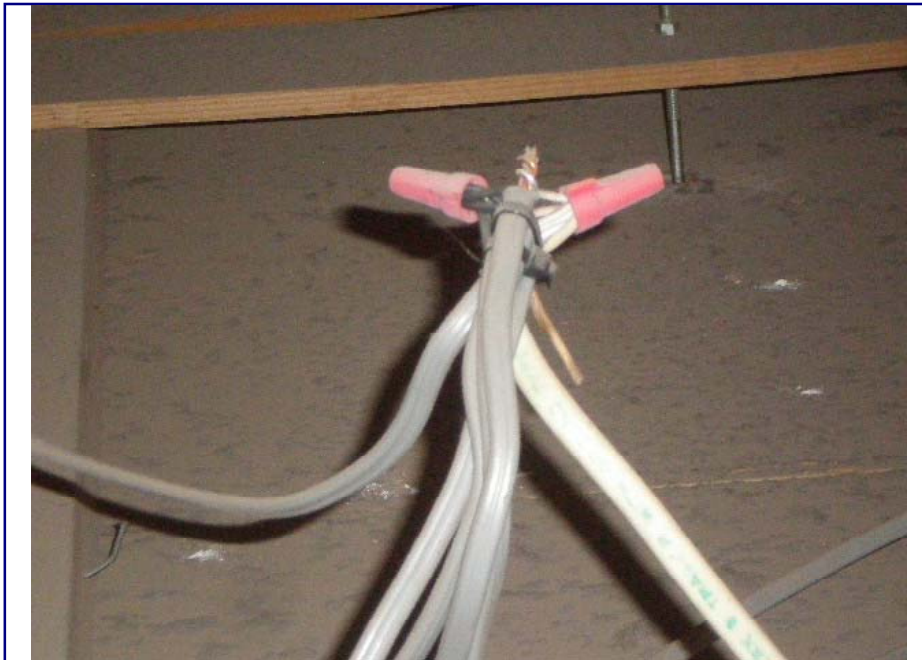
**Picture 1**

Exposed splices/ unprofessional wiring noted in the attic area, recommend electrician evaluate/ repair all wiring in attic area to help ensure proper, safe operation.(2)(4)

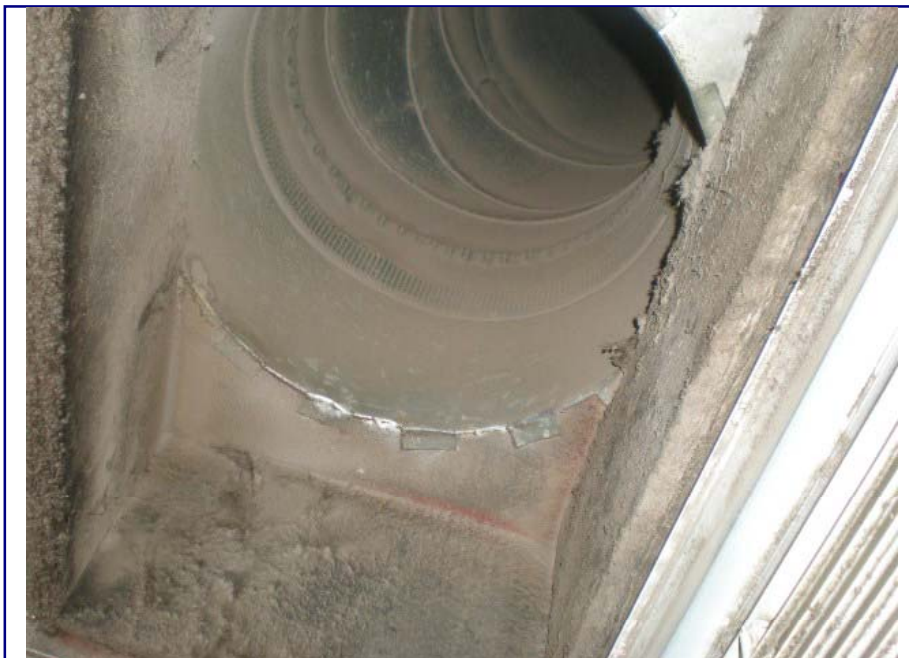
**Picture 2**

HVAC filter was missing at the time of inspection, recommend cleaning/ servicing system to help ensure proper, efficient operation.(2)

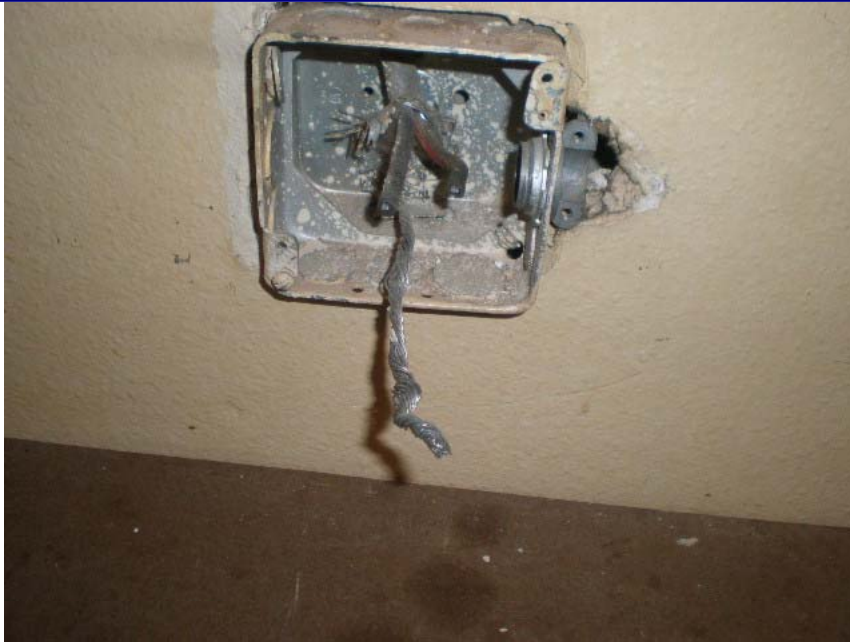
**Picture 3**

Exposed wiring at junction boxes at kitchen area.(2)(4)

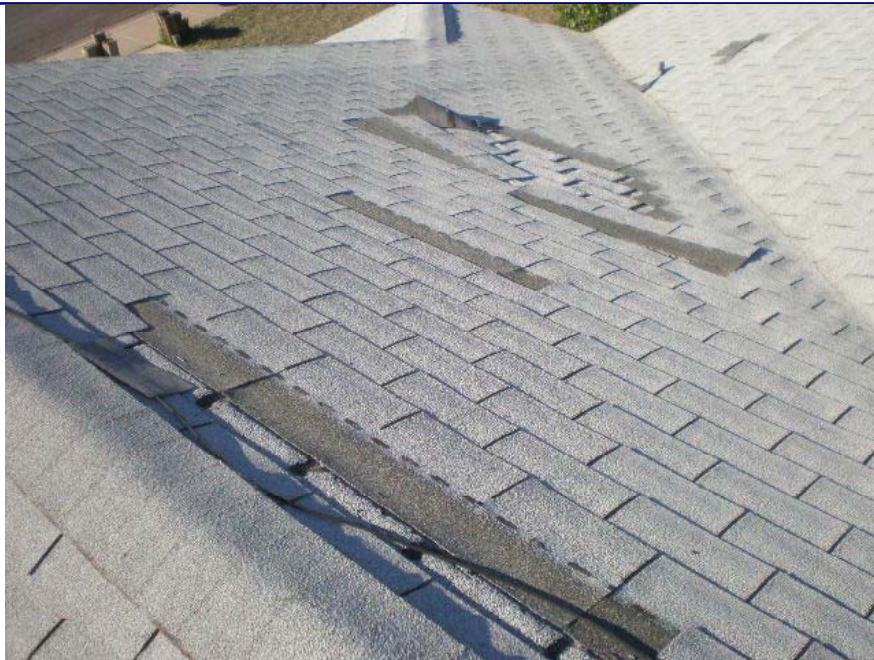
**Picture 4**

Roofing had at least two layers, unable to determine due to drip edge installation.\* Main roof had damaged/ missing shingles, and was deteriorated, recommend full evaluation/ repairs be made by a qualified, licensed roofing contractor.(2)

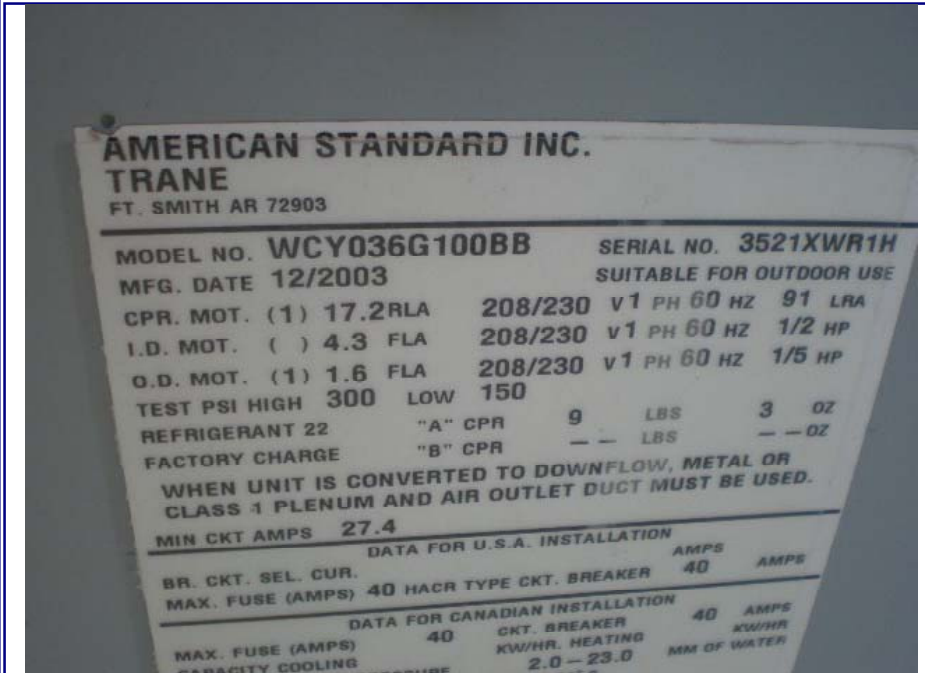
Picture 5

HVAC data plate information for your records:

Model- WCY036G10088

Serial- 3521XWR1H

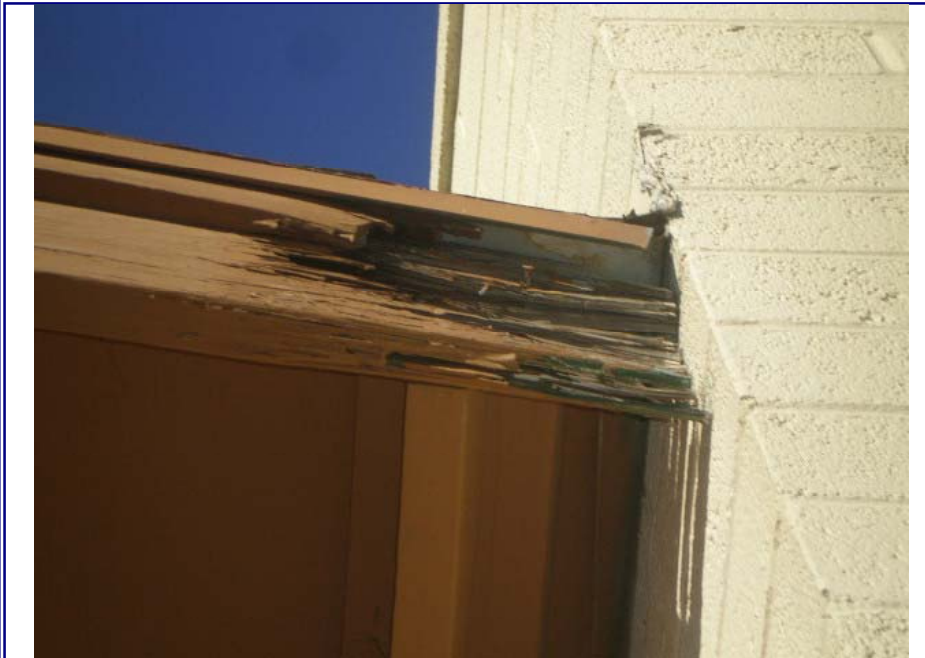
Picture 6

Damage/ deterioration noted at the fascia at the time of inspection.(2)
